Robert Stengel Princeton University April 23, 2019

Synopsis of 737 MAX-8 Accidents

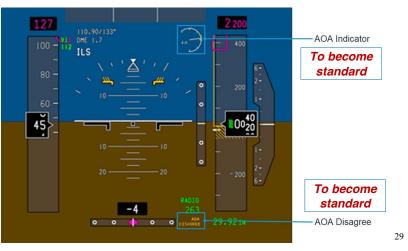
Revised 737 MAX Primary Flight Display

Separate displays for captain and first officer

- All primary flight information required to safely and efficiently operate the 737 MAX is included on the baseline primary flight display.
- Crew procedures and training for safe and efficient operation of the airplane are focused around airplane roll and pitch attitude, altitude, heading and vertical speed, all of which are integrated on the primary flight display. All 737 MAX airplanes display this data in a way that is consistent with pilot training and the fundamental instrument scan pattern that pilots are trained to use.

- The AOA (angle of attack) indicator provides supplementary information to the flight crew.
- The AOA disagree alert provides additional context for understanding the
 possible cause of air speed and altitude differences between the pilot's and first
 officer's displays.

- Information for these features is provided by the AOA sensors.
- There are no pilot actions or procedures during flight which require knowledge of angle of attack.
